# Quantifying Nutrient Reductions Achieved by Erosion Remediation Projects on Vermont's Roads

Emma Estabrook<sup>1</sup>, Beverley C. Wemple<sup>2</sup>, Mandar M. Dewoolkar<sup>3</sup>, Scott Hamshaw<sup>3</sup> University of Vermont: Rubenstein School<sup>1</sup>, Geography<sup>2</sup>, Civil & Environmental Engineering<sup>3</sup>

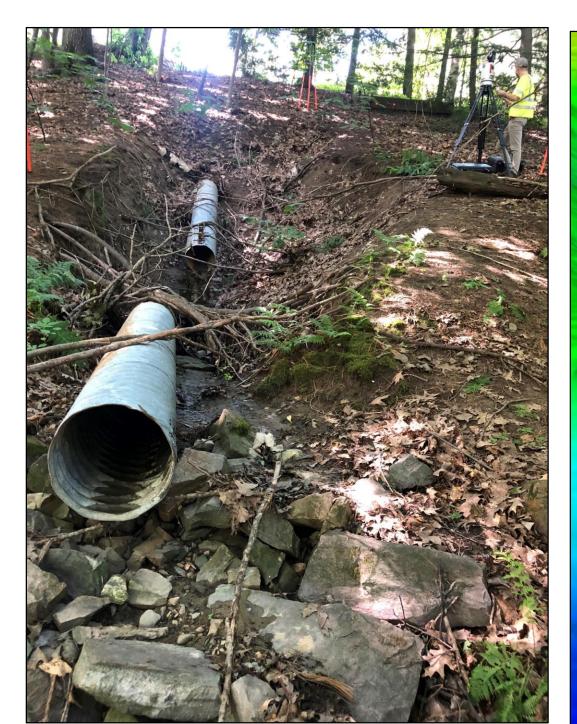
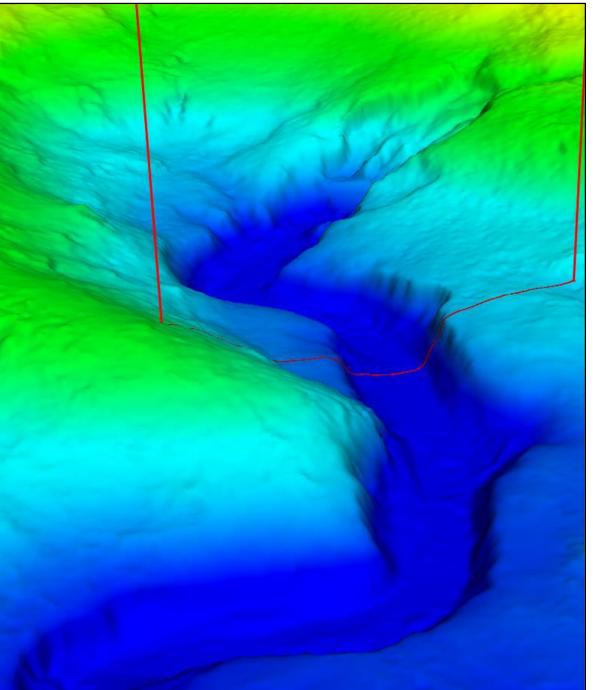
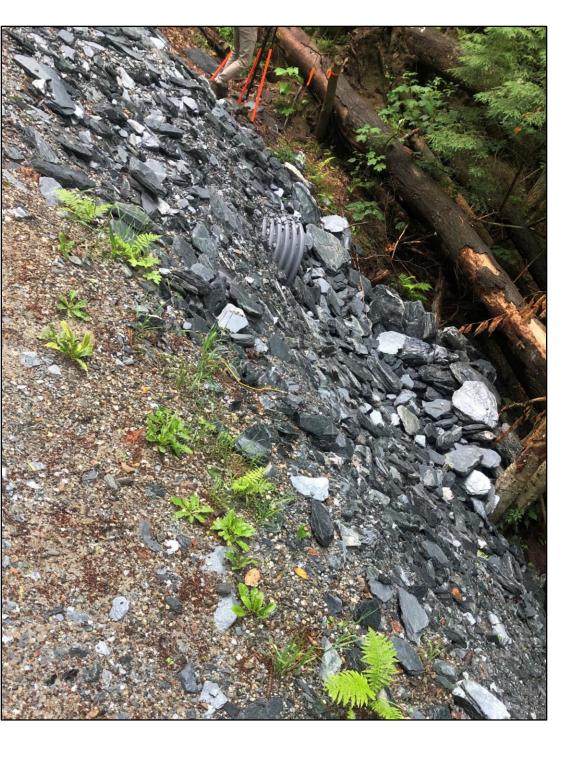
Figure 1. Left: field survey site for high resolution surveys, middle: digital elevation model derived from field surveys, and right: erosion mitigation installed at a field survey site.

A selection of gully erosion sites at concentrated road discharge points are being periodically surveyed with a high resolution terrestrial lidar scanner to monitor erosion change. To evaluate longer-term rates of gully erosion, a coarser approach will be used from airborne lidar that is more widely available and covering a longer time interval then field surveys will allow. To assess erosion control effectiveness, high resolution surveys will take place at paired treatment and control gully sites before and after erosion mitigation is installed. To evaluate longer-term effectiveness, a retrospective field assessment of best management practices previously installed.

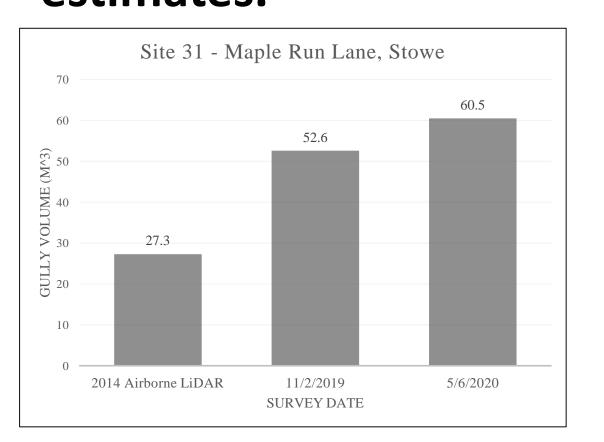
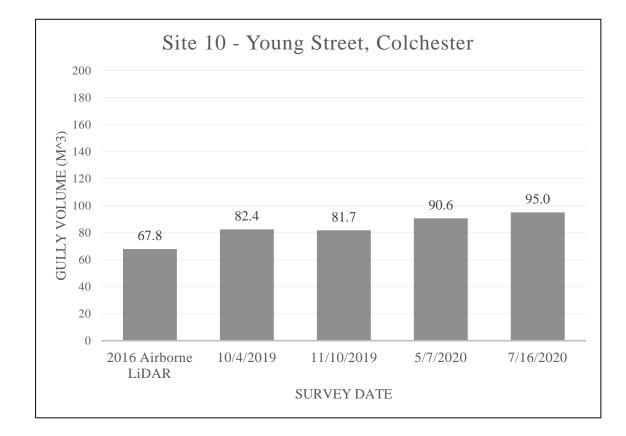
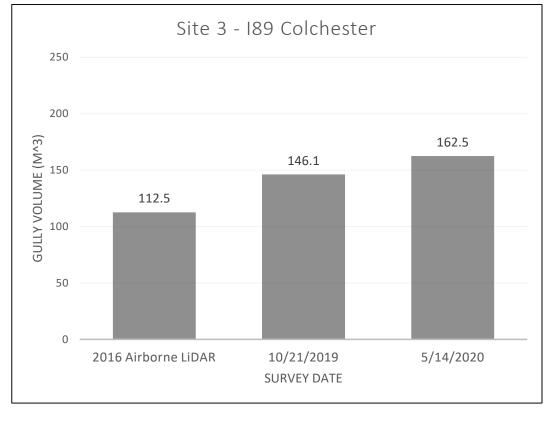
Figure 2. Gully Volume change from the 2016 airborne lidar and field surveys

Preliminary results from the field surveys show that gullies from concentrated road discharge points are increasing in volume. Eight of the 13 sites have been surveyed at least twice which allows for preliminary gully erosion rate estimates.
